Manhole Inspection Summary

Manhole # S04EE2002MH

Insp Date: **9/26/06 9:39 AM**

Location Address: **6902 PARK HEIGHTS AVE**

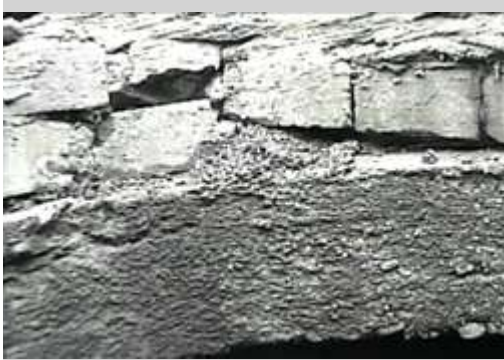
Defect

Condition: ☐ Sound ☐ Cracked ☐ Root Intrusion ☒ **Loose Brick** ☐ Deteriorated

Infiltration: ☐ None ☒ **Joint** ☐ Cracks ☐ Mortar ☐ Roots ☒ **Wall**

Adjustment deterioration and loose brick.
Adjustment infiltration.

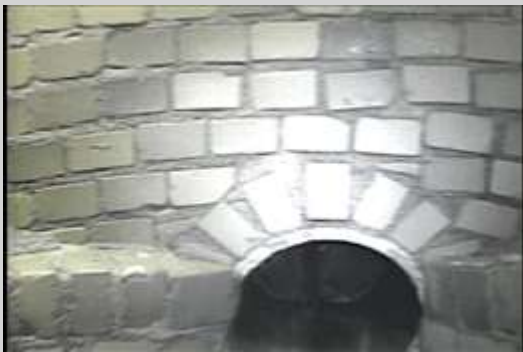
12 in. Circular Gravity Sewer Pipe Out @ 12 O'Clock

Deposits: ☐ None ☐ Mud ☐ Sludge ☒ **Debris** ☐ Grease

Silt Depth: **0** (in.) Deposits Extent: **Light**

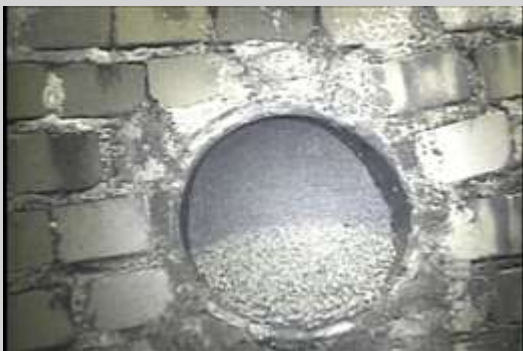
8 in. Circular Gravity Sewer Pipe In @ 3 O'Clock

3" FROM BOTTOM OF MANHOLE

Deposits: ☐ None ☐ Mud ☐ Sludge ☒ **Debris** ☐ Grease

Silt Depth: **8** (in.) Deposits Extent: **Heavy**

Connects To: **Stub connection / abandoned**

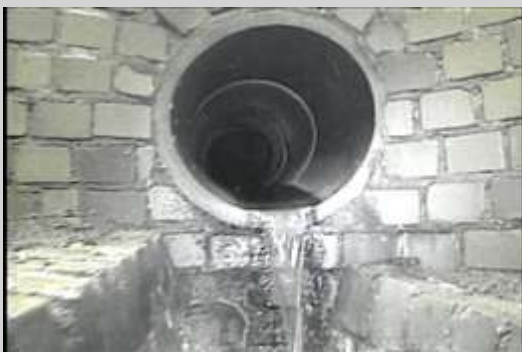
12 in. Circular Gravity Sewer

5" FROM BOTTOM OF MANHOLE
